# RESEARCH, DEVELOPMENT & TECHNOLOGY TRANSFER QUARTERLY PROGRESS REPORT

WisDOT project ID: <b>0092-14-03</b>	Other project ID:	Project start date: <b>8/13/2013</b>
Original end date: <b>2/12/2015</b>	Current end date: <b>2/12/2015</b>	Number of extensions: <b>0</b>

The current WisDOT Bridge Manual recommends using “pervious” granular backfill behind bridge abutments to prevent lateral water pressures on the abutment walls. The granular backfill material is considered “pervious” or “free-draining” based on its grain-size distribution properties. However, the “free-draining” assumption of granular backfill does not properly consider:

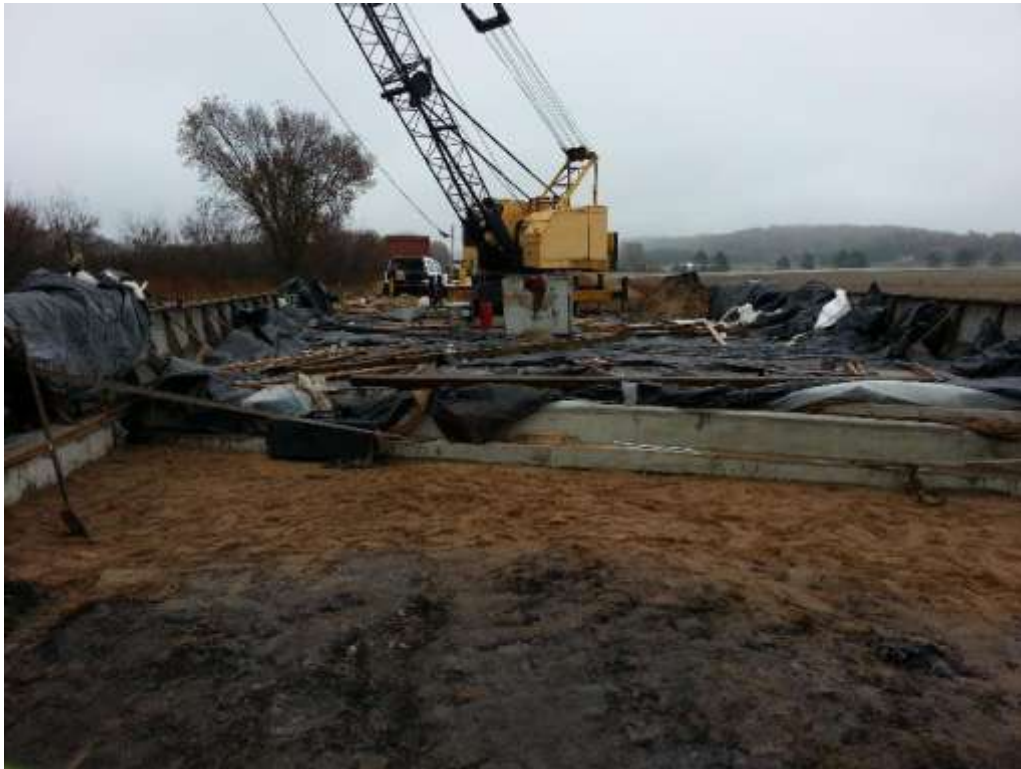
**Figure 1. West abutment on SH70 near Boyceville, WI**

Phase II – Field and Laboratory Testing: A bridge abutment backfill project on SH70 near Boyceville, WI (Figure 1) was identified by Wisconsin DOT for field testing and instrumentation. The ISU research team worked with Mr. Keopp and an onsite representative from Stevens Engineers to conduct field testing and instrumentation. Field testing and instrumentation was performed on October 31 to November 1, 2013. The project involved removing existing box culvert and replacing with a single span integrated concrete bridge with concrete abutments supported on cast-in-place piles. The height of abutment backfill was about 6 ft. A drain tile was located in the backfill at about 5 ft depth from the top of the abutment. The structural backfill material used on the bridge was poorly graded sand (classified as SP) with about 2% fines passing the # 200 sieve. The abutment backfill was topped with aggregate subbase and asphalt pavement.

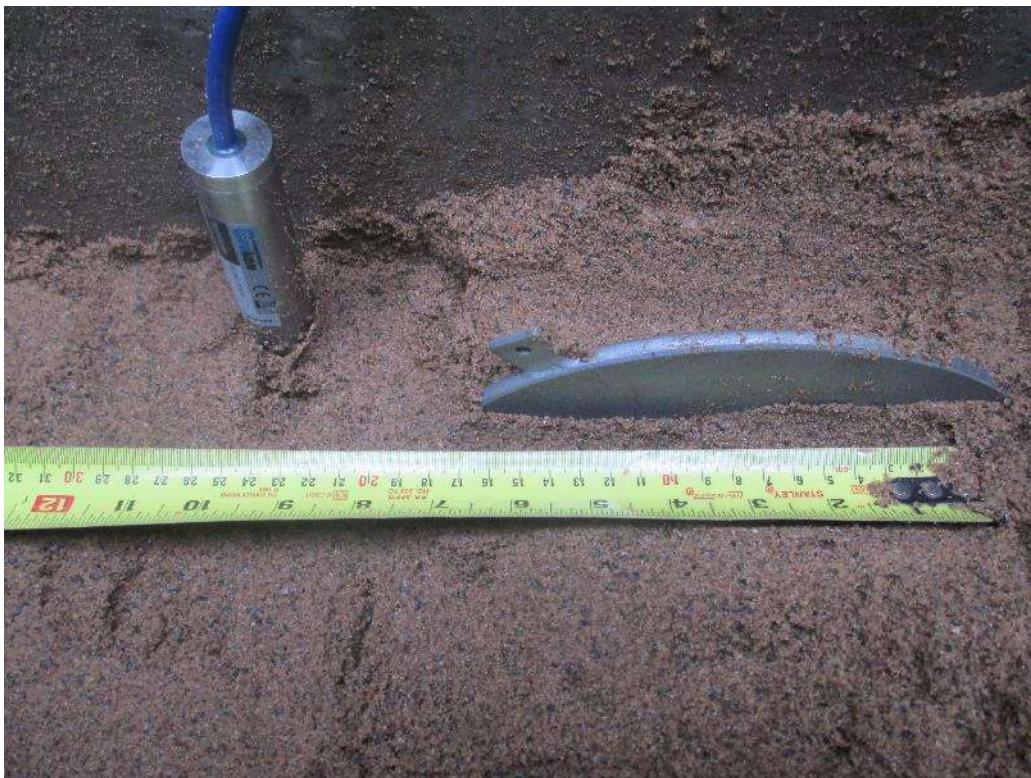
**Figure 2. PP and EPC transducers installed along the face of the west abutment wall in the backfill material**

The ISU research team conducted field testing and instrumentation on one of the bridge abutments (west abutment). Earth pressure cell (EPC) and pore pressure (PP) transducers were installed in the bridge backfill material to measure lateral stresses and pore pressures at several depths (Figure 2). Backfill material was placed and compacted to about 2 in. below its final grade, prior to our arrival. The backfill material was carefully excavated down to desired depths and compacted in thin layers (1 to 2 inches) using a hand compaction device after installing the sensors (Figure 3). Sensors were installed at four locations vertically from the top of the abutment to about 5 ft below the top of the abutment. The bottom sensors were located just above the drain tile, to capture the highest possible pore pressures due to the infiltrated water. The transducers were connected to an on-site Campbell Scientific datalogger system, which has been continuously logging data every 1 min. A field visit is planned early next quarter to download the instrumentation data.

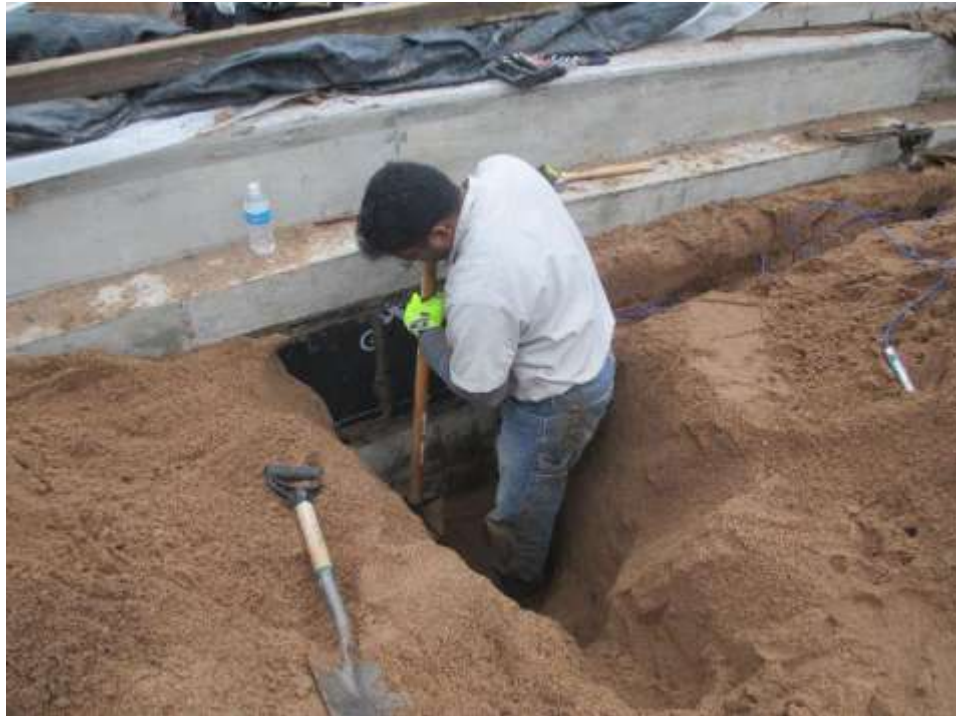
**Figure 3. Compaction of backfill material in thin layers after installing PP and EPC sensors at multiple depths**

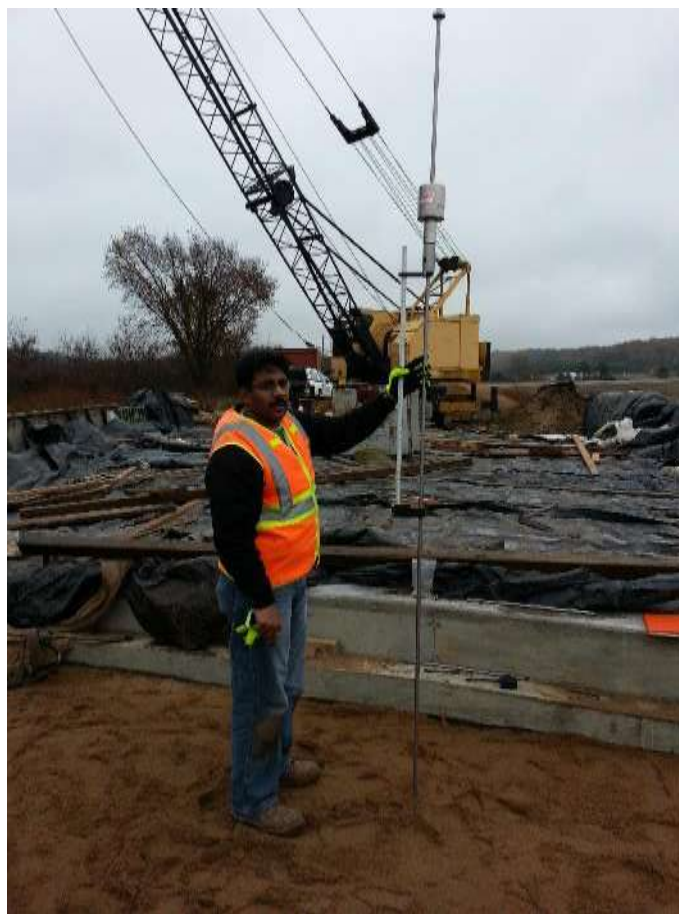
**Figure 4. DCP testing on backfill material**

Dynamic cone penetrometer (DCP) tests were conducted in the backfill material (Figure 4), down to about 9 ft below the top of abutment, to measure in situ shear strength properties and assess compaction conditions of the backfill material. DCP tests were conducted at 1 ft, 2 ft, 3.5 ft, and 5 ft away from the abutment (along the centerline) and about 10 ft away from the abutment in the existing subgrade. Field observations and test results indicated layers of loose backfill material. Air permeability testing (APT) and core hole permeability (CHP) testing was performed in the backfill material to measure the permeability characteristics of the backfill material (Figure 5).

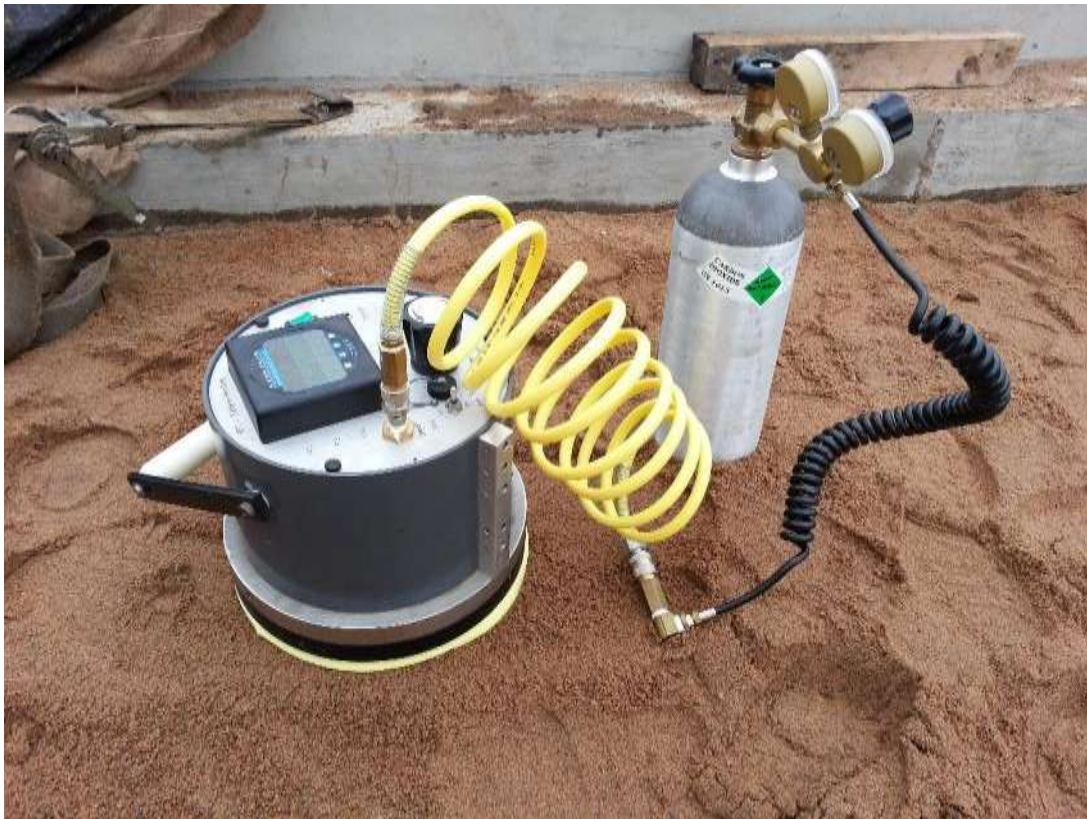
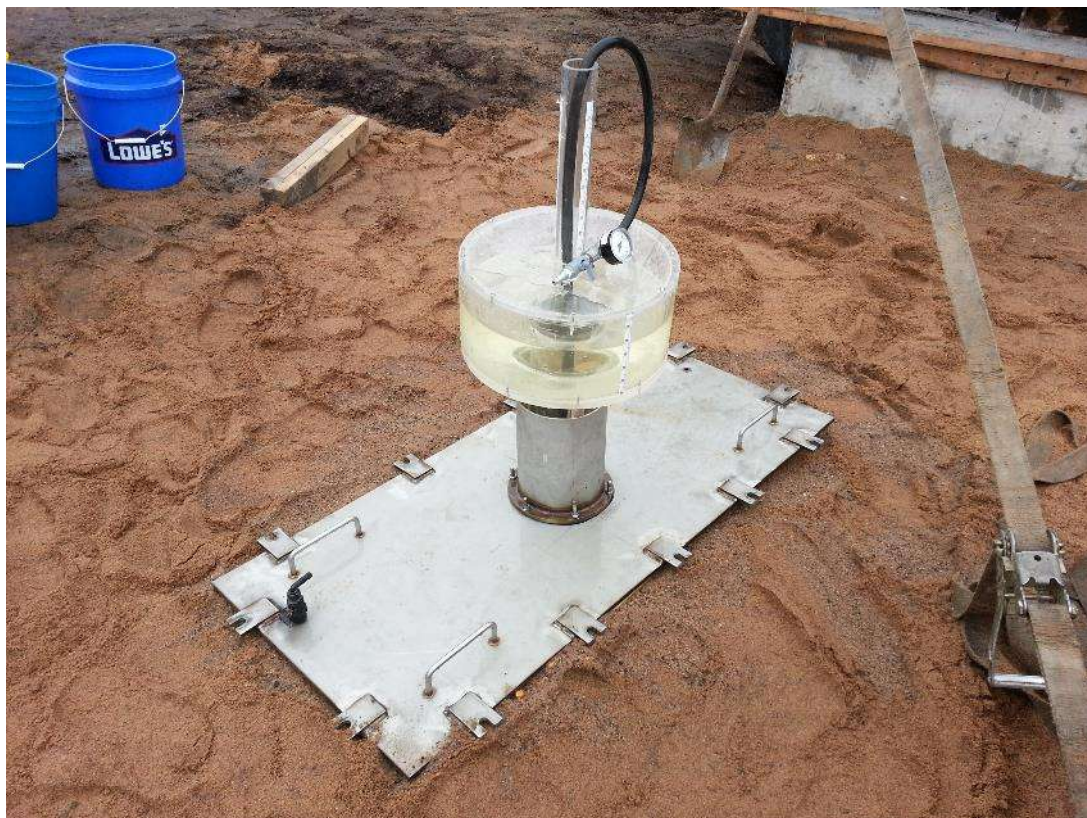
**Figure 5. Air permeability testing (top) and core hole permeability testing (bottom) on bridge abutment backfill**
